Fwd: Report of inquiry in the Accident on 02.06.23 at BNBR

Sir,
The Report of the Statutory Inquiry in the accident of the Train No.12841 (Shalimar-Chennai Coromandal Express), the Goods Train No. N/DDIP, and the Train No. 12864 (SMVT Bengaluru-Howrah Express) at Bahanaga Bazar station on 02.06.2023, at about 18:56 hrs, in Kharagpur-Ranital section of Kharagpur Division in South Eastern Railway, is enclosed herewith.
As the size of the document is large, it is divided in the two parts; the Annexures are also sent in three parts in the subsequent mails.
A.M.Chowdhary
CRS/S.E.Circle

VII. ANALYSIS

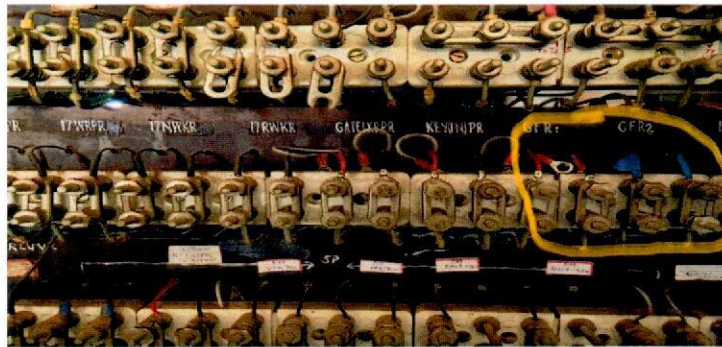
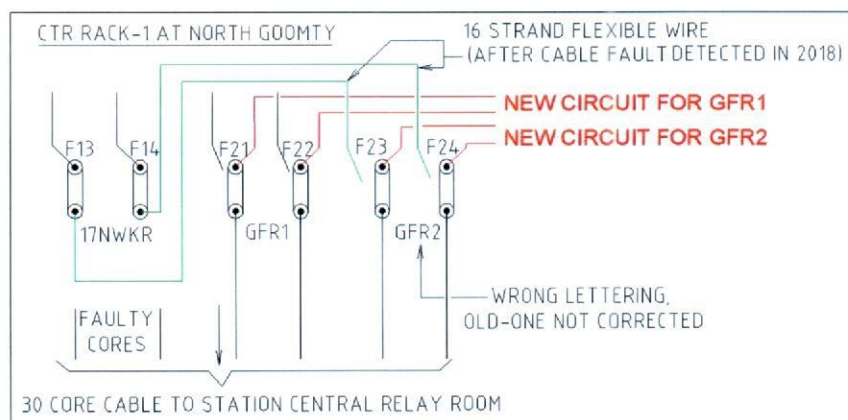
- iv. Thus, 17NWKR circuit was running on the terminals F23&F24 which were marked as GFR2 on the cable terminal rack at the North Goomty.
- v. While carrying out the wiring work of the new ELB, the S&T staff had disconnected the existing wires at terminals F23&F24, and F21&F22, assuming GFR2, and GFR1 respectively, and rewired for new ELB accordingly.

This is depicted in the following picture: -

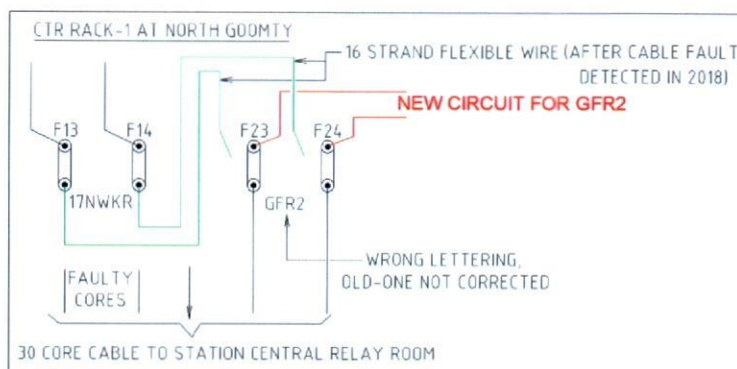
7.2.4.5 The S&T staff realized that they had disconnected the feed coming from the Crossover 17A/B to 17NWKR circuit, and instead connected 3GF RR circuit feed, which is normally available continuously, to 17NWKR circuit; thereby indication feed of Crossover 17A/B was disassociated from the status of the points at site. The following circuit diagram may please be referred in this regard:-

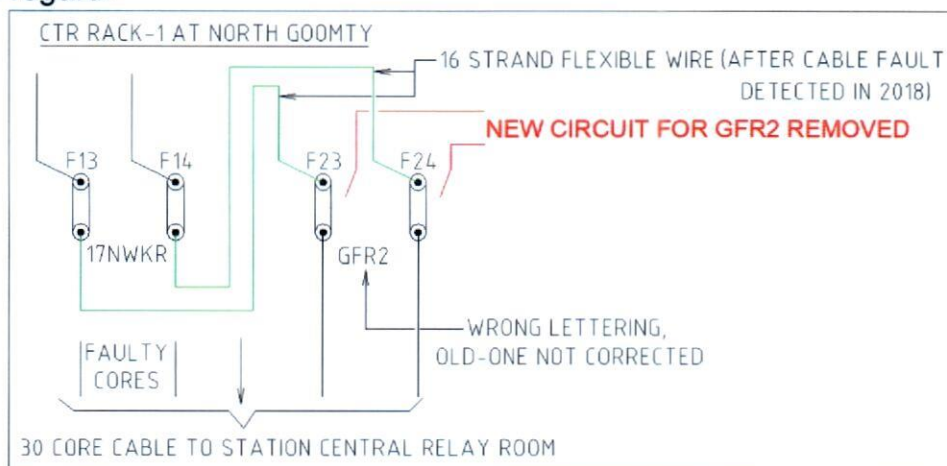
7.2.4.6 After the accident, at 23:28:51:046 hrs, 17NWK1R dropped automatically, picked up and finally dropped at 23:28:58:750 hrs. As per their deposition during the inquiry on 19.6.23, after noticing the mistake in the wiring mentioned above, second GFR (3GF RR) circuit, terminated on F23 & F24, was removed, and the originally released wires for 17NWK1R were connected back. The following circuit diagram may please be referred in this regard:-

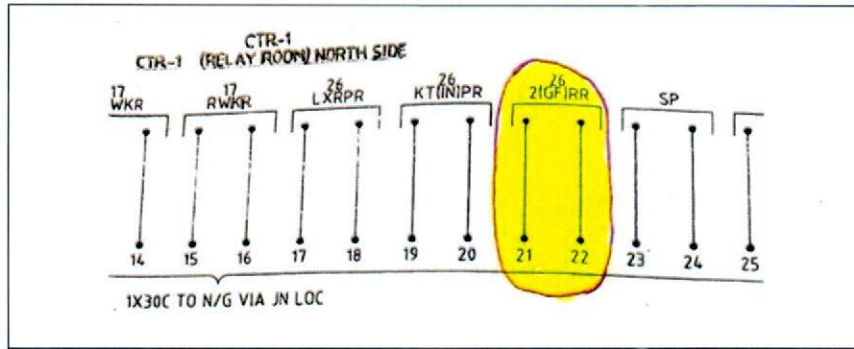
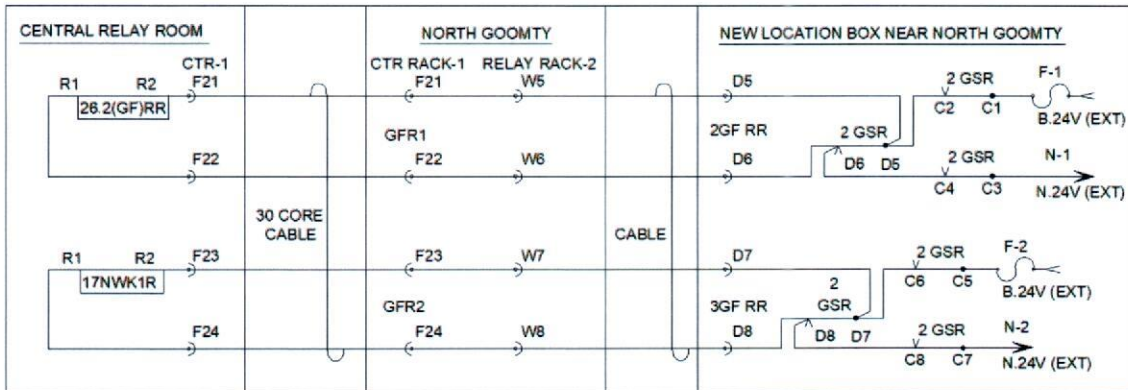
7.2.4.7 The S&T staff expressed that they were misled by following anomalies: -

- Wrong lettering on the terminal F23 & F24 as GFR2 where 17NWK1R circuit was running.
- They had no knowledge of shifting of 17NWK1R circuit from terminals F13 & F14 to terminals F23 & F24; the shifting of this circuit, wherein wires were drawn from back-side of the rack, was not visible from the front side.
- The circuit of LC 79/BLS requires two GFR circuits, viz. 2GF RR, and 3GF RR, whereas for LC 94 only one GFR, viz. 26.2(GF)RR (as designated in the Central Relay Room) was needed which was available at F-21 & F22 terminals. This following extract from the terminal chart of BNBR station [complete terminal chart is enclosed at Annexure (xiv)], and an extract of as made wiring diagram of for ELB-replacement work of LC-94 [diagram at Annexure (xv)] may please be referred in this regard: -

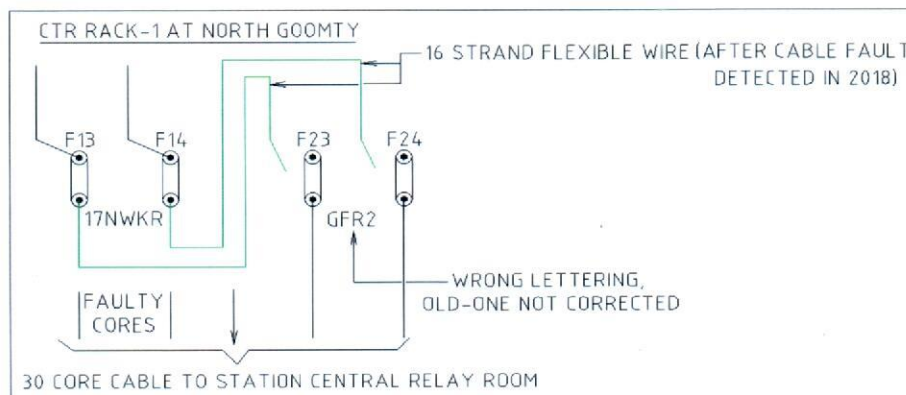
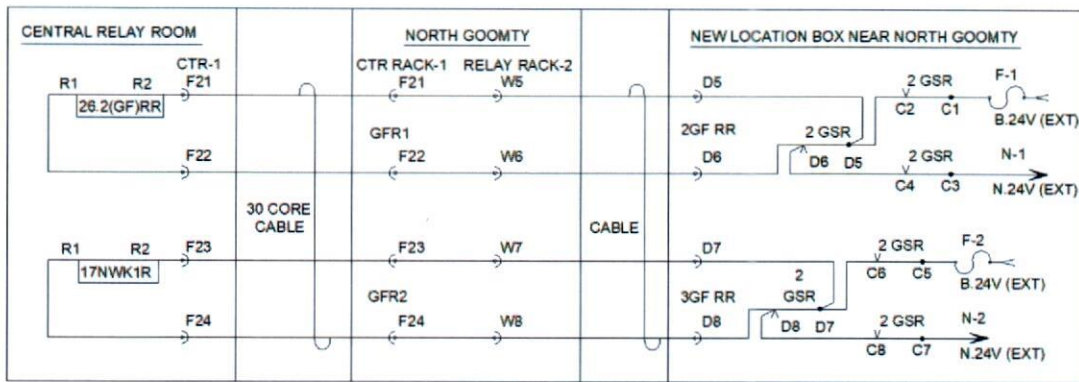
8.1.1 The first instance of point failure of the Crossover 17A/B, on 02.06.23, was recorded at 16:20:53:437 hrs, wherein it unexpectedly failed at Normal position.

Explanation: After obtaining disconnection permission at 16:20 hrs, the point failed as the 17NWKR circuit was removed from terminals F23 & F24 on CTR Rack-1 for replacement of GFR2 circuit as per the lettering on these terminals by connecting second GFR (3GF RR) circuit of LC 94 as per the wiring diagram of LC-79/BLS. The following circuit diagrams may please be referred in this regard: -

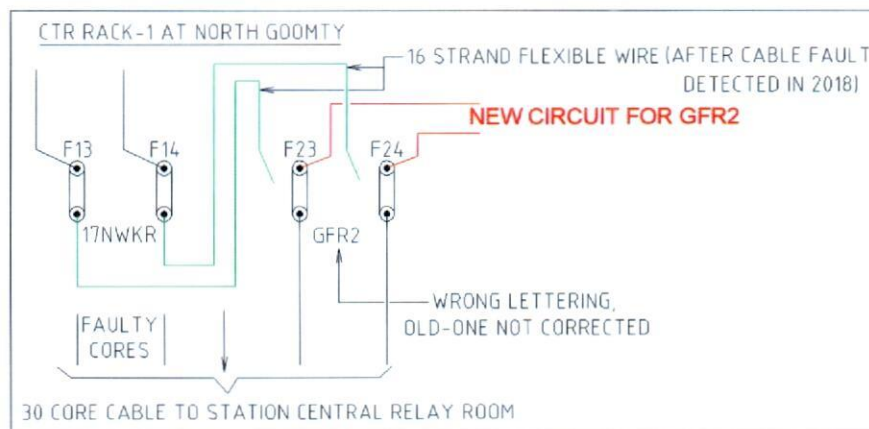
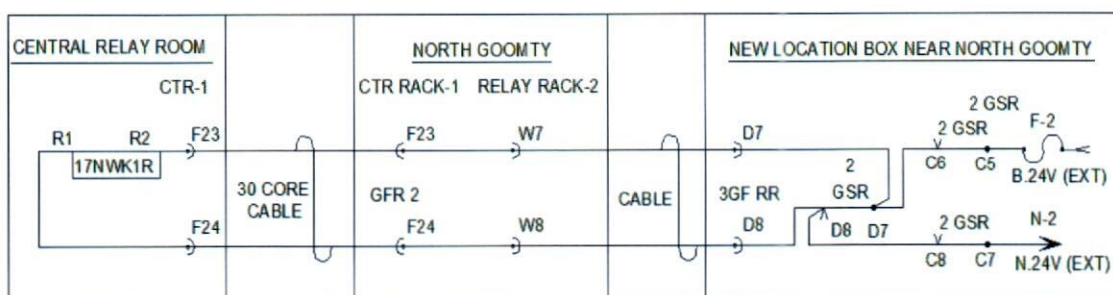
8.1.2 Then SM/BNBR operated the crossover A/B through individual-operation from Normal to Reverse, it took usual time of around 14 seconds, but when he operated the point through individual-operation from Reverse to Normal, it took around 37 seconds and the crossover A/B was set to Normal at 16:22:19:671 hrs – this was unusual.

Explanation: The second GFR (3GF RR, as per the circuit of LC-79/BLS) circuit of LC 94 was connected at 16:22:19:671 hrs at terminals F23 & F24 of CTR Rack-1 of North Goomty, and its feed was extended to the Central Relay Room for 17 NWK1R. Since this feed is normally available, feed to the 17NWK1R was available permanently irrespective of the status (Normal or Reverse) of the Crossover 17A/B. Though the Crossover 17A/B was set to Normal at site, but its indication relay (17NWK1R at Central Relay Room) picked up only after connection of the second GFR circuit at 16:22:19:671 hrs – this explains the reason for time of 37 seconds instead of usual time of 13 to 14 seconds. The following circuit diagrams may please be referred in this regard:-

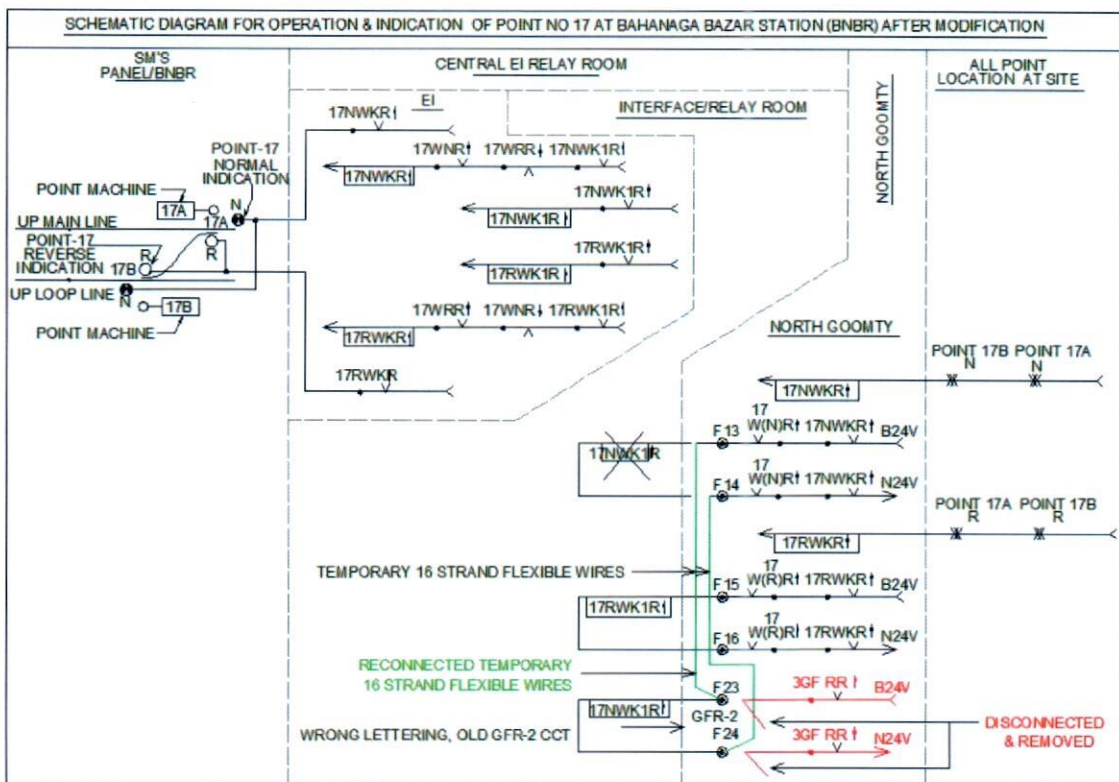
8.1.3 Further, the Crossover 17A/B was set to Reverse from Normal at 18:14:22:953 hrs through initiation of the Signal Route 1B, i.e., for reception of an UP Goods train on the UP-Loop line. Subsequently, with the same point setting, another Goods train No. N/DDIP was received on the UP-Loop line, and the Route 1B was released at 18:34:52:968 hrs.

Explanation: The design of Point circuit was such that though NWK1R was in picked up state, it was possible to operate the point to Reverse from Normal. As the Point reverse indication circuit was not disturbed, keeping correspondence with actual site condition, 17RWK1R was picked up at the Central Relay Room. As the command relay WRR was in picked up state (which forced dropped relay WNR), 17NWK1R logic got dropped though 17NWK1R was picked up – this allowed 17RWK1R to pick up. Thus, the Signal could be taken off for the UP loop line. The following circuit diagrams may please be referred in this regard:-

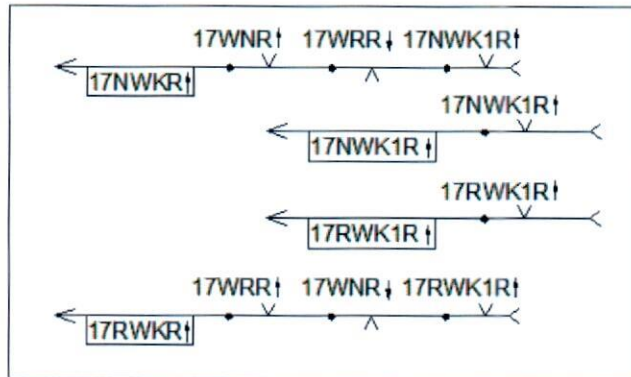
- i. From 16:22:19:671 hrs, 17NWK1R (in central relay room) was in picked up state with the feed of the second GFR/LC 94, and when the Crossover 17 A/B was set to reverse at 18:14:22:953 hrs, 17RWK1R (in central relay room) picked up in correspondence with the point status at site. It may be observed that both 17 NWK1R, and 17RWK1R were in picked up state from this time. The moment individual command was initiated, the logic bit 17NWK1R in EI picked up immediately as pick up state of 17NWK1R was readily available by false feed [of

second GFR circuit (3GF RR)]. The following extract of the schematic diagram of operation and indication of crossover 17A/B [the complete drawing at Annexure (xvi)] may please be referred in this regard:-

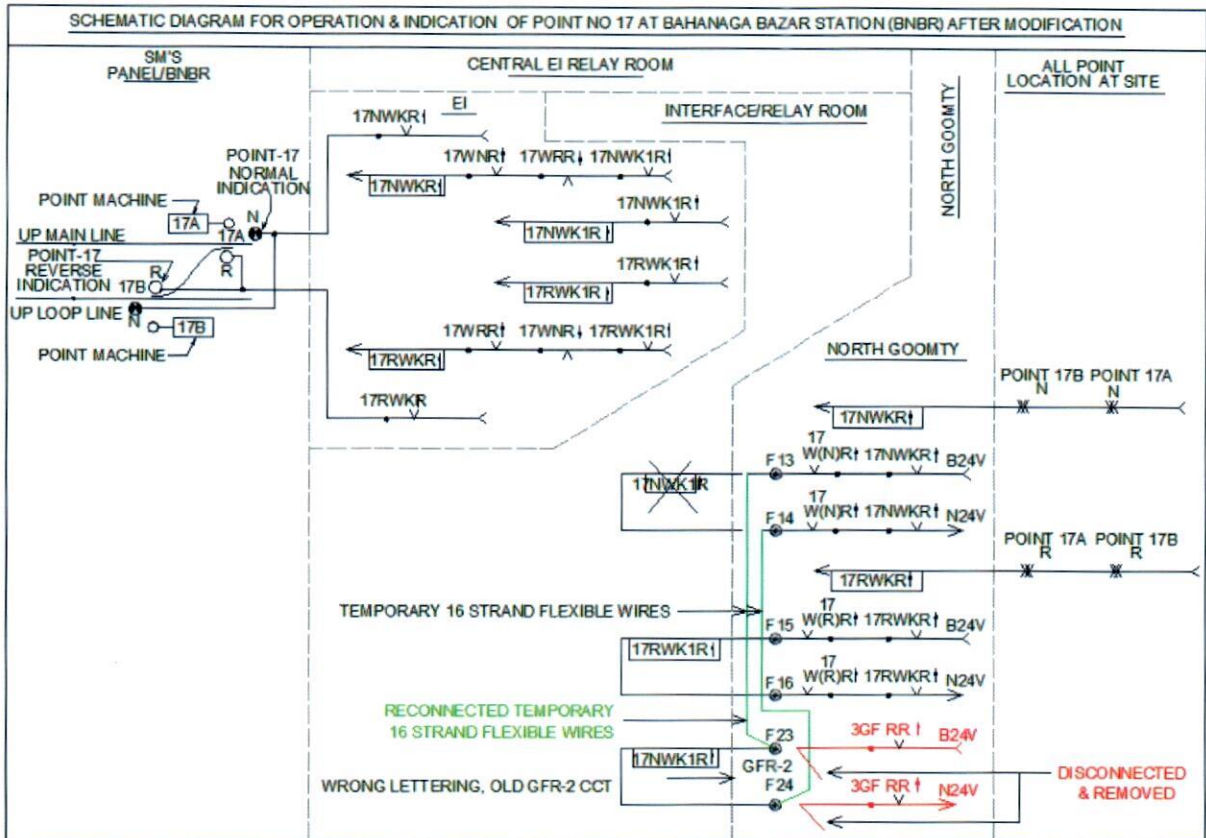
- i. As 17NWK1R was already in picked up state, even after initiation of individual command for operating the point from Reverse to Normal, the command was not extended to the North Goomty and 17W(R)R latch relay remained in picked up state at the North Goomty. Through this latch relay pick up, feed at the North Goomty was extended to 17RWK1R.
- ii. Though both 17NWK1R and 17RWK1R were in picked up state, as the last command logic bit (17WNR) for Normal operation of Crossover 17 A/B was in picked up state, it force-dropped 17WRR and thereby 17RWKR logic bit became low, and allowed 17NWKR to high in EI logic. Due to this, Normal indication of the Crossover 17A/B was available on the Panel even when it was Reverse at site.

The following circuit diagram [also at Annexure (xvi)] may please be referred in this regard:-

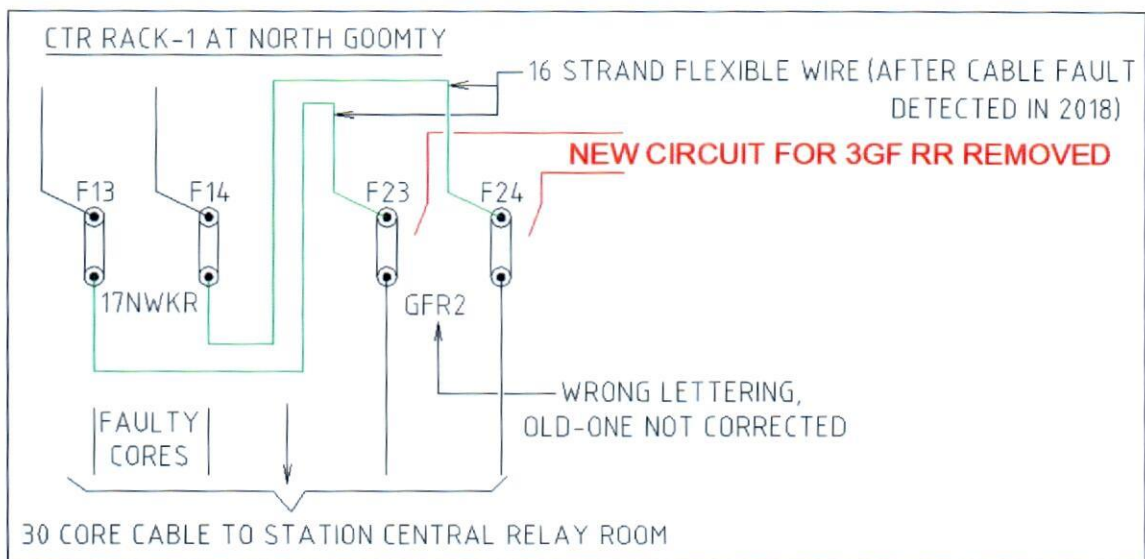
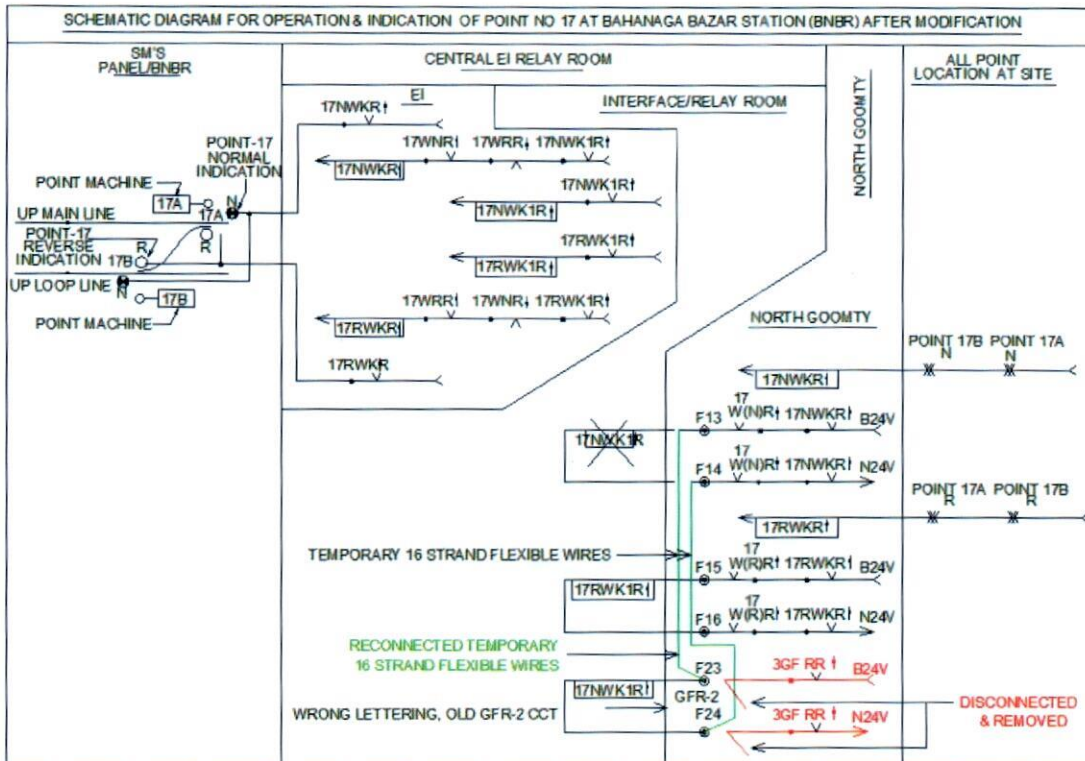
8.1.9 After the accident, at 23:28:51:046 hrs, 17NWK1R dropped automatically, picked up and finally dropped at 23:28:58:750 hrs.

Explanation: As per the deposition of Shri Amir Khan SSE/Sig/SFO, Shri A.R. Mohanty Tech III/BNBR, Shri Pappu Kumar Tech III/BLS, Shri A.K..Mohanta, SSE/Sig/Incharge, during the inquiry on 19.06.23, after noticing the mistake in the wiring mentioned above, second GFR circuit (3GF RR), terminated on F23 & F24, was removed and the original released wires for 17NWK1R were connected back at North Goomty. Now 17NWK1R restored back in association with the status of Crossover 17 A/B. As point machines of points 17A & 17 B were damaged, the detection-feed from the points was disconnected and that's why 17NWK1R dropped at the North Goomty, and feed to 17NWK1R at the Central Relay Room was also discontinued. This is clear from the circuit diagrams given hereunder [and at Annexure (xvii)]:-

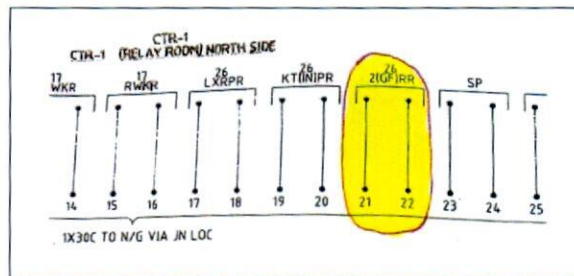
- iii. From the cable termination diagram of F-Row of the CTR-Rack-1 of the Central Relay Room (connected to the CTR-Rack-1 at the North Goomty), approved on 05.01.2015 (extract shown hereunder), it can be seen that only one GFR circuit was allotted at terminals F21 & F22 of CTR-1 for the purpose of LC-94. Whereas, in the wiring diagram of LC 79, two numbers of GFR circuits were required. Had only one GFR circuit been wired at the corresponding terminals at F21 & F22 at the North Goomty on CTR Rack-1, there would have been no need to alter the circuits at F23 & F24 (where the 17 NWKR circuit was extended from terminals F13, & F14) for the wiring of second GFR circuit (3GF RR as per wiring diagram of LC 79), and thereby this accident could have been prevented.
